Mehr Petrochemical Co.

Environmental Performance

National Iranian Petrochemical Co. (NPC)

13-Jun-2015

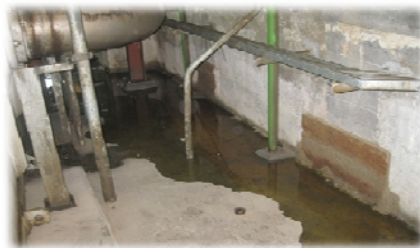
Sample Incident Reporting	
Incident Case : Environmental Incident (Lube oil spillage) Date : August 17, 2010 (1389.05.26)/ Place : Extruder lube oil unit at Pelletizing House	
Event : MT team removed the inserted temporary mesh out of the 16" discharge pipe. They could not insert the gasket in between, so that it was needed to loosen the other end flange bolts connecting to the bottom elbow of lube tank. It was time consuming to drain oil inside the tank again so, they loosened the other end flange bolts and let the oil spill around.	
Root Causes : <ul style="list-style-type: none"> - No awareness of the oil spill (Potential of accident) - Work under pressure

Corrective Action : <ol style="list-style-type: none"> 1. Provide safety training to improve their awareness 2. Provide more supervision
